Seismic Activity of Adana City and Assessment of the Building Stock Regarding Earthquake Risk

^{*1}Ilyas Saribas and ¹Gokhan Beyaz

^{*1} Faculty of Engineering, Department of Civil Engineering, Adana Alparslan Türkeş Science and Technology University, Adana / Türkiye

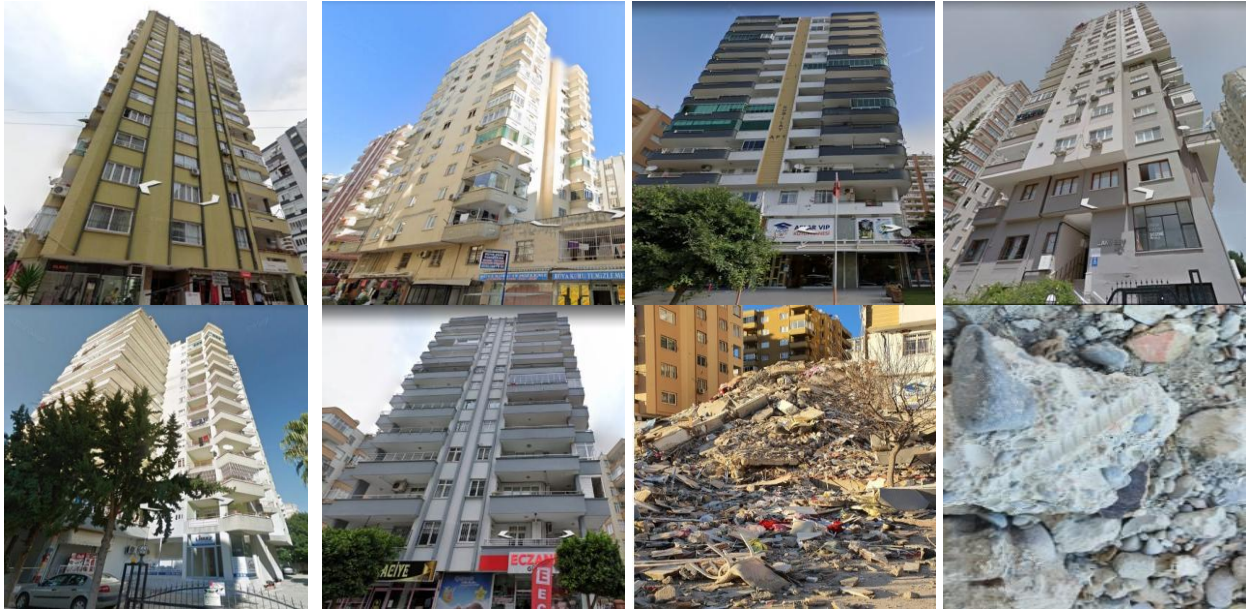
commonly observed in the buildings of Adana. A significant proportion of the buildings that succumbed during the earthquake exhibited characteristics of heavy overhangs (Fig. 5). The confinement of reinforced concrete members is executed utilizing stirrups; particular emphasis is placed on the tightening of stirrups, especially in the regions of column-beam joints. Insufficient confinement reinforcement is a common issue observed in structures that experienced collapse during earthquakes in Adana (Fig. 5).

Figure 5. Collapsed buildings and material conditions in Adana City [8]

reinforcement bars, which may diminish their cross-sectional area long before they complete their intended service life. This type of deterioration can adversely affect the load-bearing capacity of the reinforced concrete members. This issue is particularly alarming for structures situated in earthquake-prone areas, jeopardizing both human lives and property. Fortunately, thorough examinations of the remains of collapsed buildings in Adana often reveal evidence of corrosion on the reinforcements, allowing us to learn and improve.
