Seismic Activity of Adana City and Assessment of the Building Stock Regarding Earthquake Risk

^{*1}Ilyas Saribas and ¹Gokhan Beyaz

^{*1} Faculty of Engineering, Department of Civil Engineering, Adana Alparslan Türkeş Science and Technology University, Adana / Türkiye

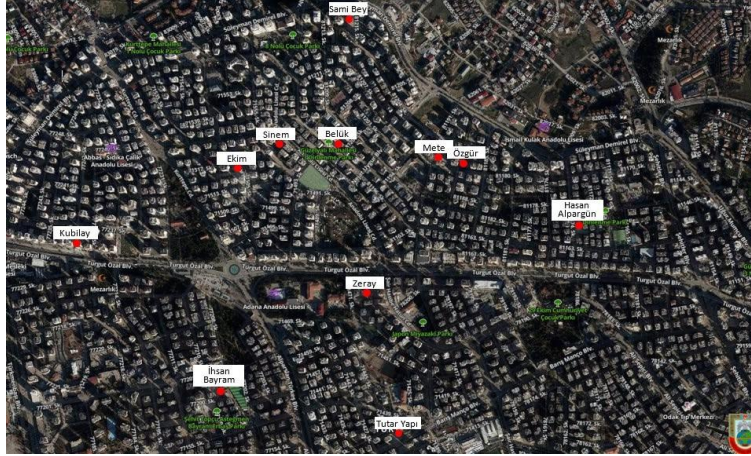
Figure 3. Location details of buildings destroyed in the earthquake in Adana [9]

Adana, one of the eleven cities, suffered profound effects from the earthquakes, with significant damage and loss of life primarily occurring in the northern part of the city. As a result, eleven multi-story buildings collapsed in Adana, leading to a total of 418 fatalities. The locations of these collapsed structures are shown on the map provided in Fig. 3. Notably, the clustering of these collapses in an area distant from the earthquake's epicenter is striking. The northern region of Adana is generally recognized for its high-quality ground. However, local residents who previously lived in this area have reported that stream beds once flowed through this region. Currently, these stream beds have completely disappeared due to extensive construction activities.

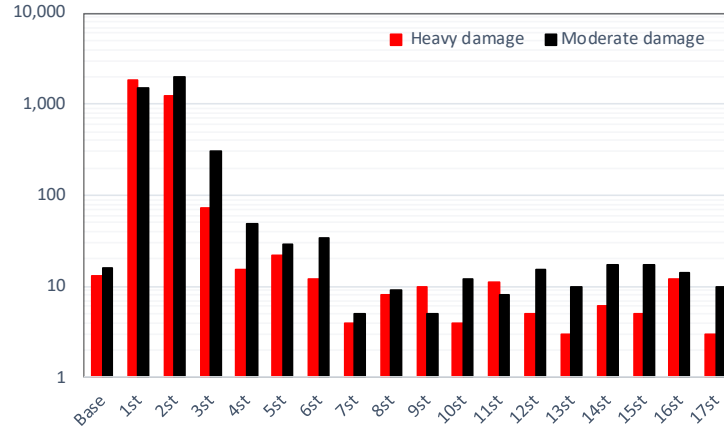
Figure 4. Number of buildings with severe or moderate damage based on story height in Adana City

The distribution of buildings exhibiting severe or moderate damage in Adana City, categorized by their number of stories, is illustrated in Figure 4. It is observed that the prevalence of buildings with severe and moderate damage is significantly high throughout the city. An earthquake that may occur in Adana, which is encircled by active fault lines, would considerably affect the region and result in substantial destruction. Consequently, it is imperative to evaluate the condition of both structures under construction thoroughly and those that are completed and currently in operation. The damages causing loss of life and property in previous earthquakes were similar to those observed in reinforced concrete and masonry structures in Adana following the February 2023 Kahramanmaraş earthquakes. The destruction that occurred in Adana relates to the following damage situations: Rigidity differences between the stories of structures cause soft stories and weak stories. Generally, removing infill walls on the ground story or increasing the ground story height for commercial purposes leads to soft story irregularities. During the earthquake, this soft story with less rigidity causes more displacement, causing damage to the structure and even collapse. Such damage situations were also encountered in the collapsed structures in Adana (Fig. 5). The difference between the column designed length and the real length in situ during earthquakes causes a short column effect. The fact that the walls are not raised along the stories and the presence of strip windows also increase this effect. This damaged situation emerges as a notable problem in buildings collapsed due to earthquakes in Adana City (Fig. 5). In Adana and ten other cities affected by the earthquakes, challenges related to concrete quality were observed in nearly all collapsed and severely damaged structures. Nonetheless, concrete is recognized as one of the key materials essential for a structure's performance during seismic activity (Fig. 5). The condition in which the upper story area of a building exceeds that of the lower story is referred to as a "heavy overhang." Heavy overhangs extend the distance between the centers of gravity and rigidity of the structures, adversely influencing their performance during seismic events. Such structural irregularities are
